## Sweetening The Deal – Overcoming Confectionary Issues

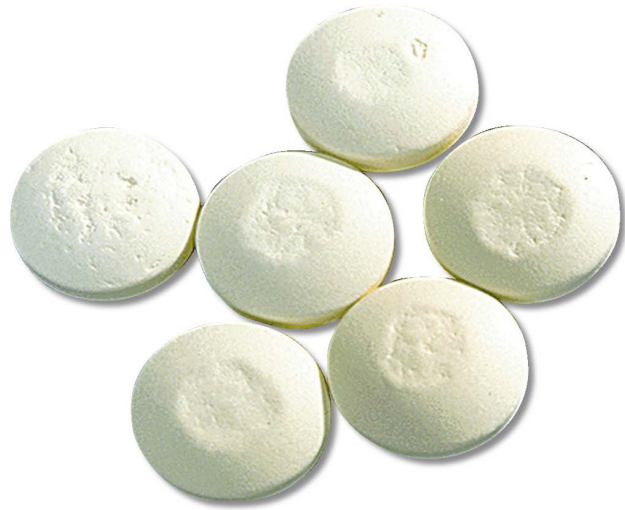
#### Core erosion takes place during the coating process

Before fixing their issue with I Holland, our customer had been experiencing core erosion, flashing and edge chipping. Whilst the root cause in the case study was the worn punches creating defective tablets, other preventative measures can be carried out. Core erosion takes place during the coating process due to abrasion from the coating pan and the tablet bed. Worn tooling can cause defects, but it is important to also consider other causes and solutions. Core erosion could be happening because the tablet core is too soft, the coating pan speed is excessive, or the tablet design is inappropriate e.g. the surface area of the tablet is too small. Overly soft tablet cores can be solved by increasing tablet hardness within the tolerance but ensure to not exceed the tooling maximum press force during manufacture. Fortunately, solving excessive coating span speed is simpler – slow down the

pan speed. If you suspect the issue may be caused by inappropriate tablet profile, then it is time to rethink the design of the tablet itself. For this solution it's always a good idea to work with your tooling supplier to optimise the tablet, as they often know best, and can keep the redesign process realistic and efficient. Tablet edge chipping and flashing can also be caused by worn tooling, and the same solutions as above can be utilised to minimise this problem. For tools with signs of wearing, using a thorough and correct polishing procedure can solve issues of flashing, however once a punch is too worn, it must be replaced.
